Retrofit Solutions

FOR TRANSFORMER BUSHINGS

Rated Voltage : 24 kV ~ 245 kV

Application : Transformer - Outdoor

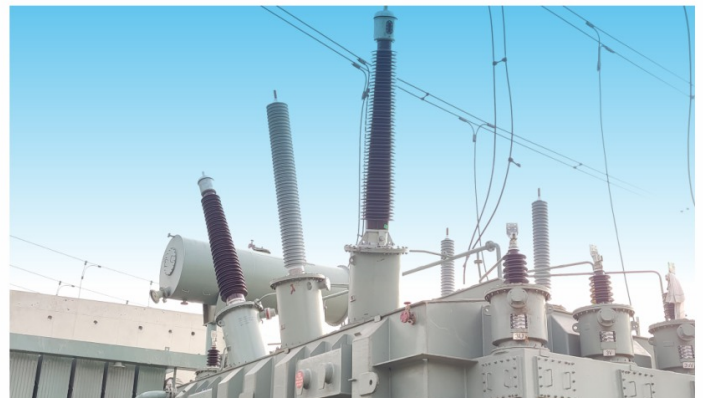
Y RIP Bushing installed on a transformer as a replacement to existing OIP bushing in Y phase with R&B phase operating with the old OIP bushings.

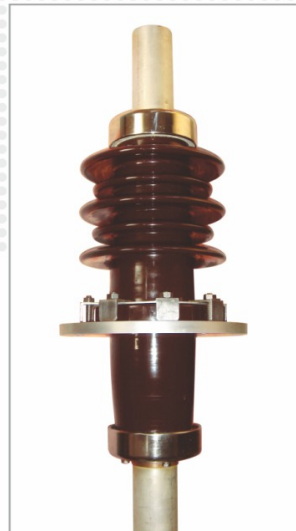
24 kV 4000 A, 5000 A, 7500 A TELK design retrofit - Developed & Supplied to various NTPC sites through reputed Transformers manufacturers such as ABB & EMCO Limited

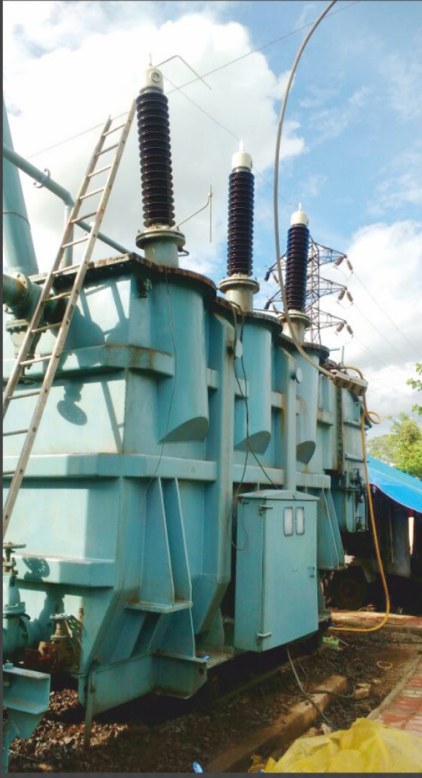
145 kV OIP bushing as Retrofit to old 145 kV SRBP Bushing at MPPTCL Khandwa

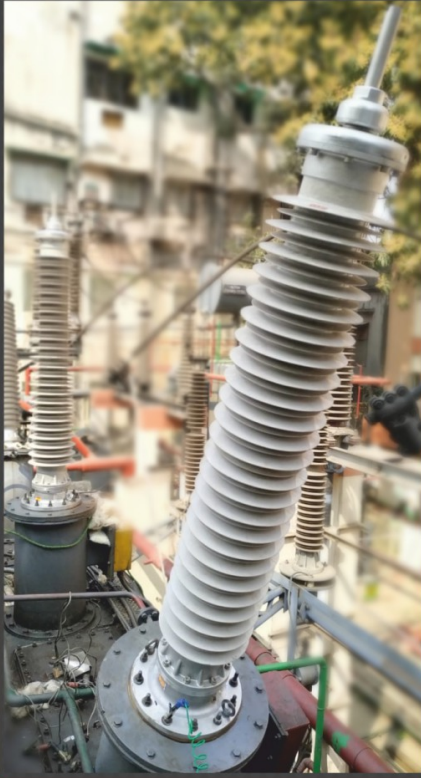
145 kV RIS bushing as Retrofit to old 145 kV OIP Bushing at CESC

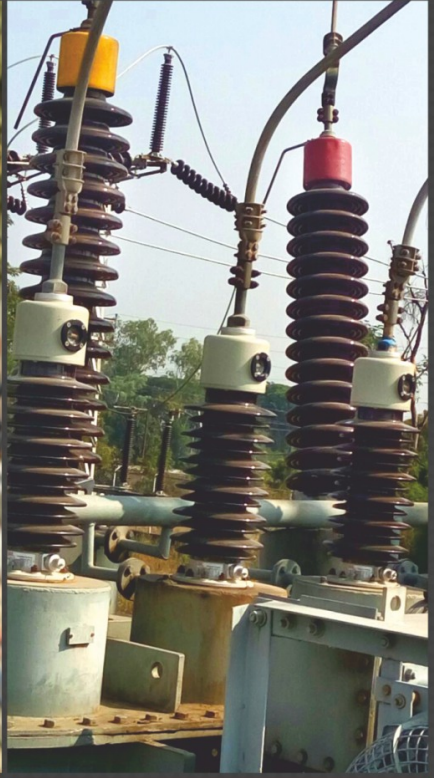
52 kV OIP bushing as Retrofit to damaged OIP Bushing at MPPTCL

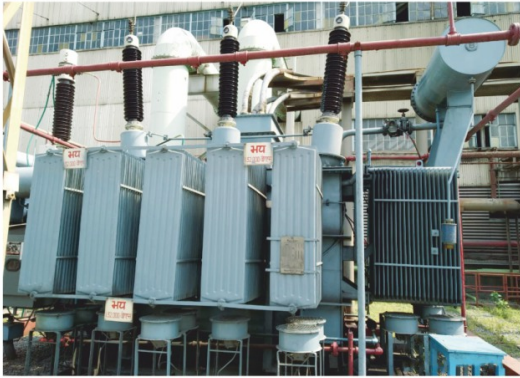
145 kV OIP bushing as Retrofit to damaged OIP Bushing at Hindalco

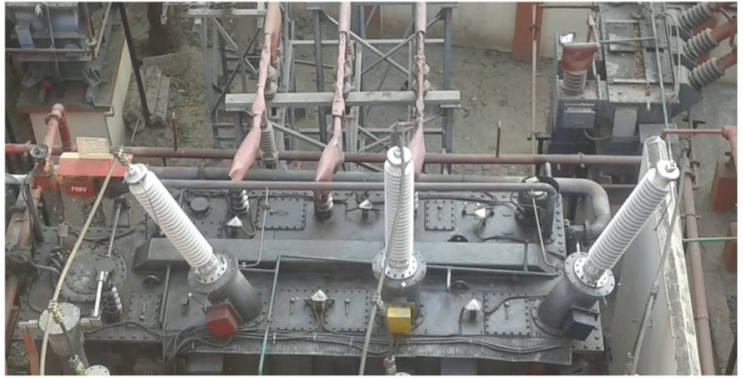
145 kV 800 A 600 CT RIS bushing as Retrofit to old 145 kV OIP Bushing at CESC (a prominent private Utility in Eastern India)

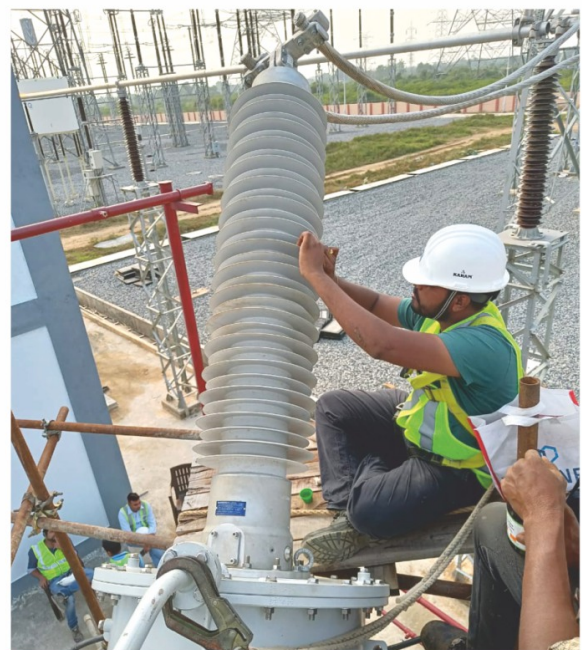
On-site Bushing repairing being carried out

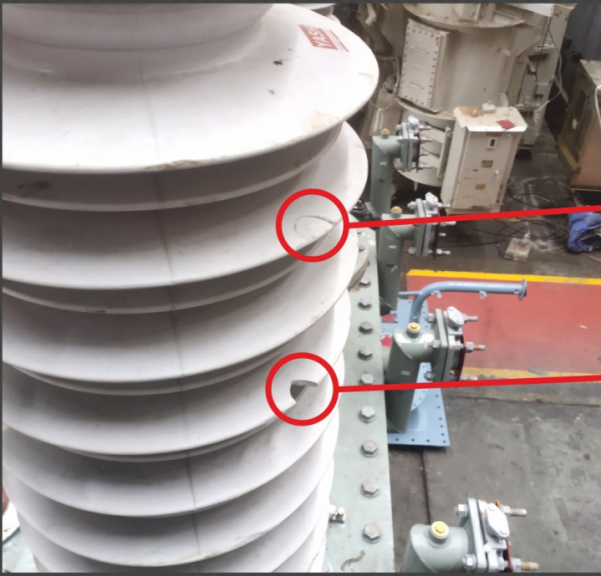
Damaged Silicone sheds at site

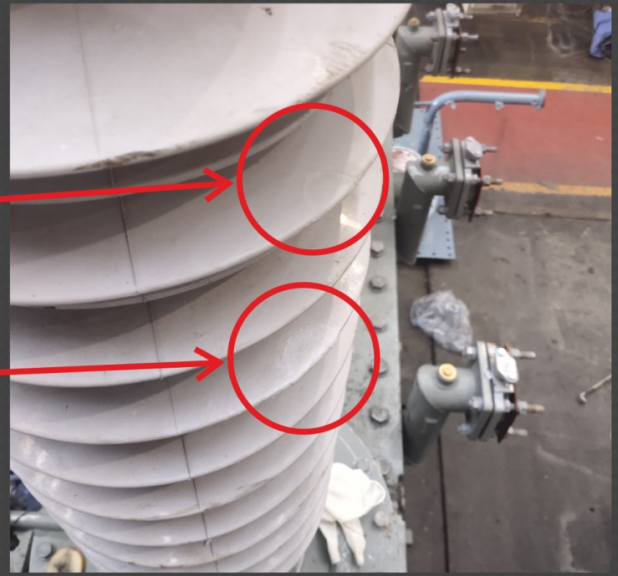
Repaired Silicone sheds on-site

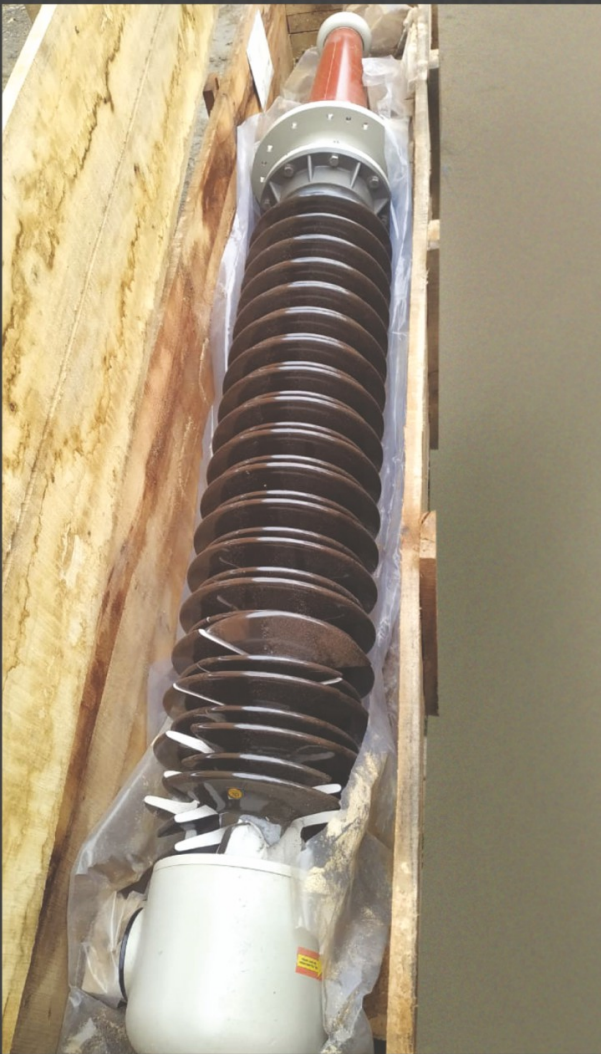
145 kV OIP bushing with transit damage to Air end porcelain

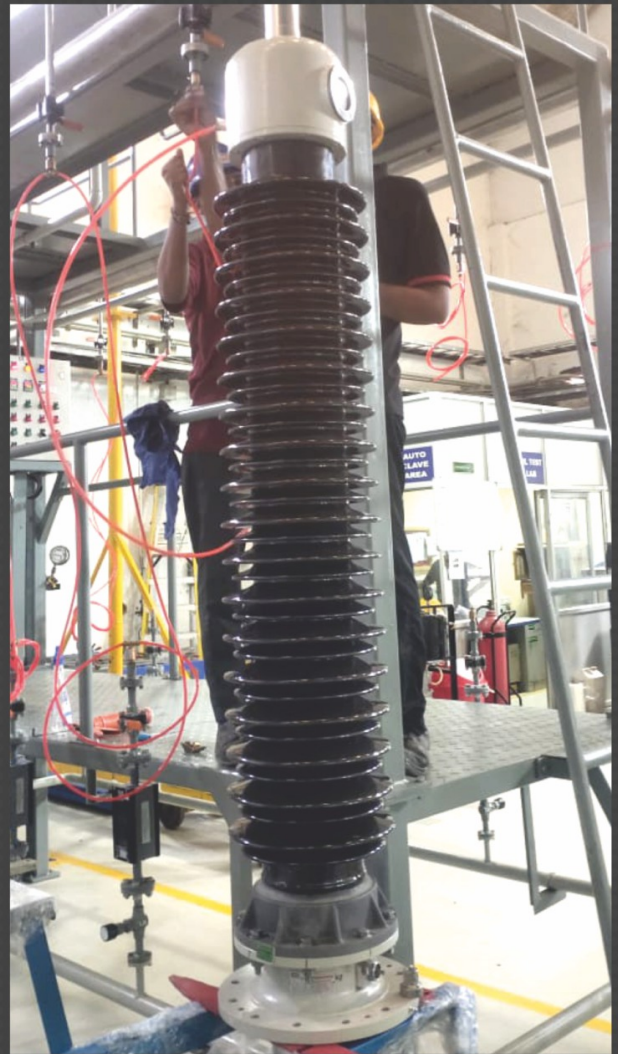
Porcelain part replacement, Bushing refurbished and supplied after complete routine testing
